FURLEX B, C OCH D

CONNECTION FAILURE BETWEEN LOWER LUFF EXTRUSION AND ADAPTER

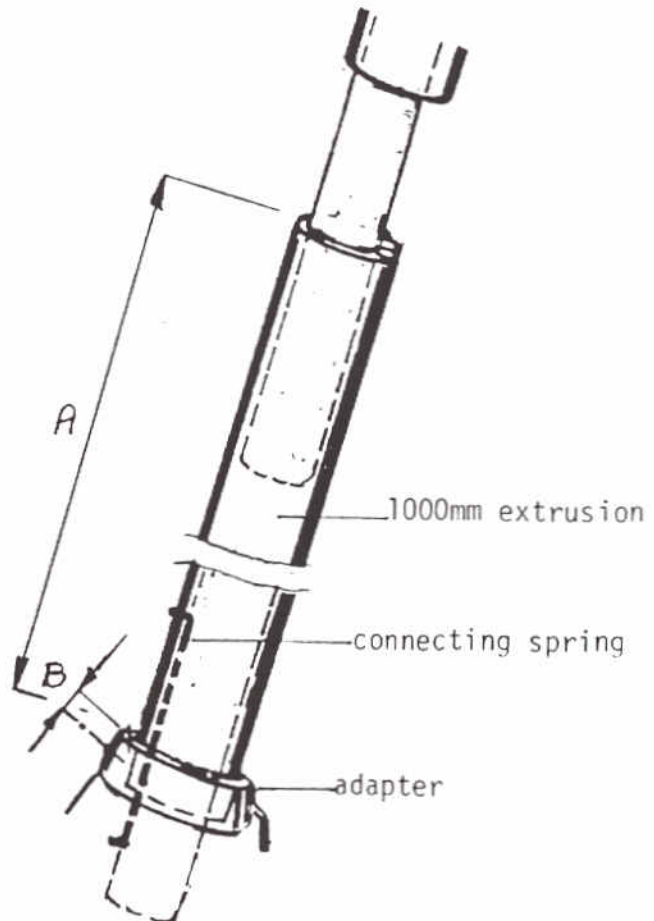
In most cases the failure is due to halyard tension being transferred to the luff extrusion by:

- oversized luff tape dimension has been fitted
- luff tape has jammed in the sail feeder
- the halyard has been tensioned while the sail is furled.
- the sail has been made with an overlength luff which allows the halyard swivel to push up the top guard.
- failure to connect the tack shackle before tightening the halyard after a rapid sail change.

1. Check that the luff section is pushed firmly into the adapter. Check by comparing the dimension "A".
2. Drill a 5.3mm hole on the front line of the adapter, the distance "B" below the top of the adapter. The FURLEX kit contains a drill bit of the correct size. Pre-drilling 2mm deep using a 3mm drill bit is recommended Angle the hole down so that the screw head will lie flush with the front surface of the adapter. The hole will be 12-15 mm deep. On type B the drill bit will stop against the connecting spring at a depth of about 10mm. The screw the requires a packing washer, see item 3
3. Fit a self-tapping screw MRX 6x12(part number 155-613, exactly as used for the halyard leads). On type B fit a nylon washer (part number 164-001) to compensate for its shallow hole, see item 2.

As an alternative, drill 5.0mm and tap M6 after which a M6 machine screw can be used.

FURLEX	LUFF SECT.	A	B
B	31x20	985	7
C	40x27	980	10
D	50x34	980	10
